INFORMATION BULLETIN

No.001

SUBJECT : BATTERY CHARGER INSTALLATIONS

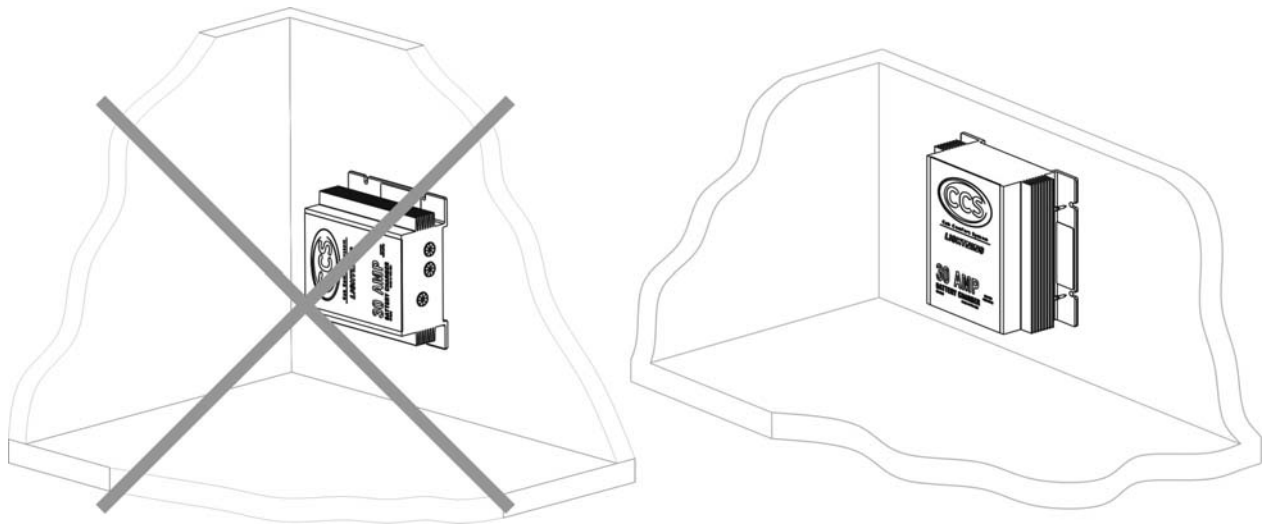
There have been several occurrences where the battery chargers have been mounted in a manner that is not a recommended installation procedure. The result is improper cooling of the battery charger leading to potential failures.

It is not recommended to install the battery charger in an horizontal upright position as illustrated. Customers should be advised to return to the installing dealer to correct the problem.

This repair is NOT covered under the CCS Lightning warranty.
