INFORMATION BULLETIN

No.002

SUBJECT : **POWER DISTRIBUTION BOX**

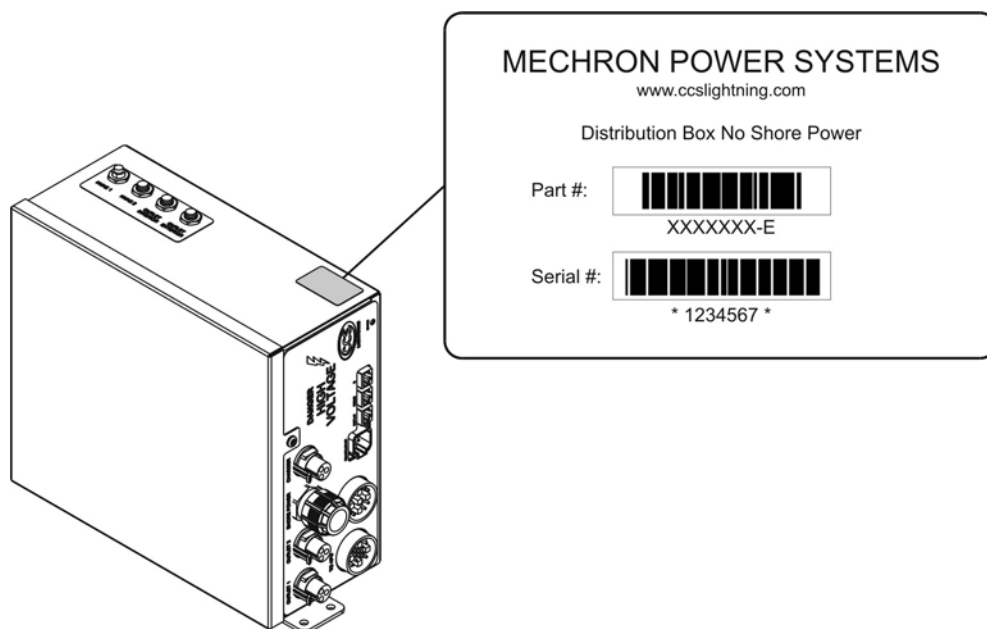
There have been occurrences where Power Distribution Boxes have had flash codes 1-2-5-7 with no (or 1) flash code on the APU and the customer complaint will be that the air conditioner stops working when operating in high ambient temperatures.

If no faults with sensors or air conditioning can be found and the problem continues to repeat itself after clearing flash codes (done by removing the 7.5A ECU Battery Fuse - see fig. 2.1 page 22 of the Work Shop Manual), return Power Distribution Box to Mechtron for repairs.
