**LIGHTNING**

# SERVICE BULLETIN No.006

<b>PRODUCT MODEL</b>	: CCS Lightning
<b>BULLETIN TYPE</b>	: Product Testing
<b>MANUAL / SECTION</b>	: N/A
<b>PARTS LIST REVISION</b>	: N/A
<b>EFFECTIVE DATE</b>	: June 27, 2006
<b>SUBJECT</b>	: <b>HVAC Performance Evaluation Procedure</b>
<b>UNITS AFFECTED</b>	: S/N < 61499999
<b>PARTS AFFECTED</b>	: N/A
<b>TERMS &amp; CONDITIONS</b>	: N/A

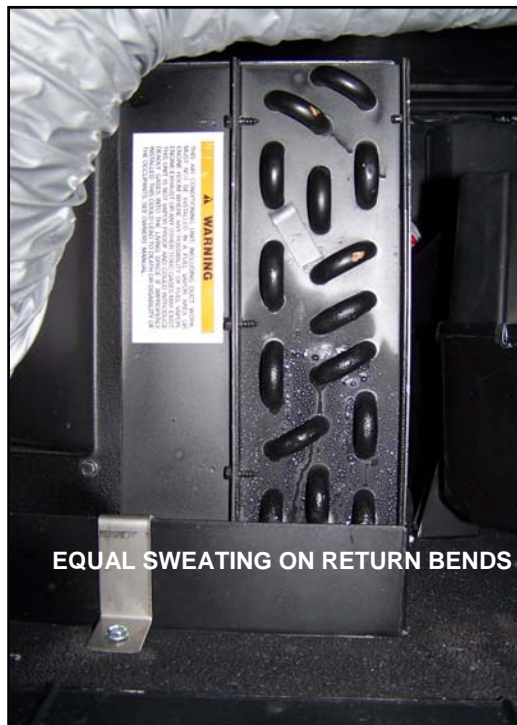
Figure 1

1. Turn unit on in COOL mode; allow to operate for five minutes.
2. After five minutes, look for the following:
  - a. On the **10K unit**, the return bends on the evaporator coil should be cold and sweaty all the way up the coil (Fig. 1)
  - b. On the **14K unit**, the coil circuitry is a little different. The return bends should be checked for saturation height (**All three coils should be sweaty to equal heights**); as well as making sure each of the three circuits is active (Fig. 2). The return bends should be cold and sweaty all the way up the coil (Figure 1.)
3. The unit should have at least 15°F (8°C) differential from intake at the coil to discharge grill with the Fan on high.

The CHEB units cooling capacity is in question due to possible capillary tube defect. Please perform the test (see next page) and if the unit fails to meet criteria #2 and #3, the CHEB should be replaced.
