LIGHTNING

SERVICE BULLETIN No.003

PRODUCT MODEL	: CCS Lightning
BULLETIN TYPE	: Product Correction
MANUAL / SECTION	: N/A
PARTS LIST REVISION	:
EFFECTIVE DATE	: November 10, 2005
SUBJECT	: ENGINE COOLANT HOSES
UNITS AFFECTED	: 20060-20119, 20245-20266, 20269, 20647, 20652-20654, 20679, 20688, 20691, 20692, 20694, 20697, 20698, 20701, 20703-20704, 20714, 20716-20718, 20721, 20728, 20729, 20734, 20745, 20747, 20748, 20762, 20769, 20773, 20781, 20785, 20789
PARTS AFFECTED	: 1060810 – Coolant hose, Outlet & 1060811 – Coolant hose, Inlet
TERMS & CONDITIONS	:

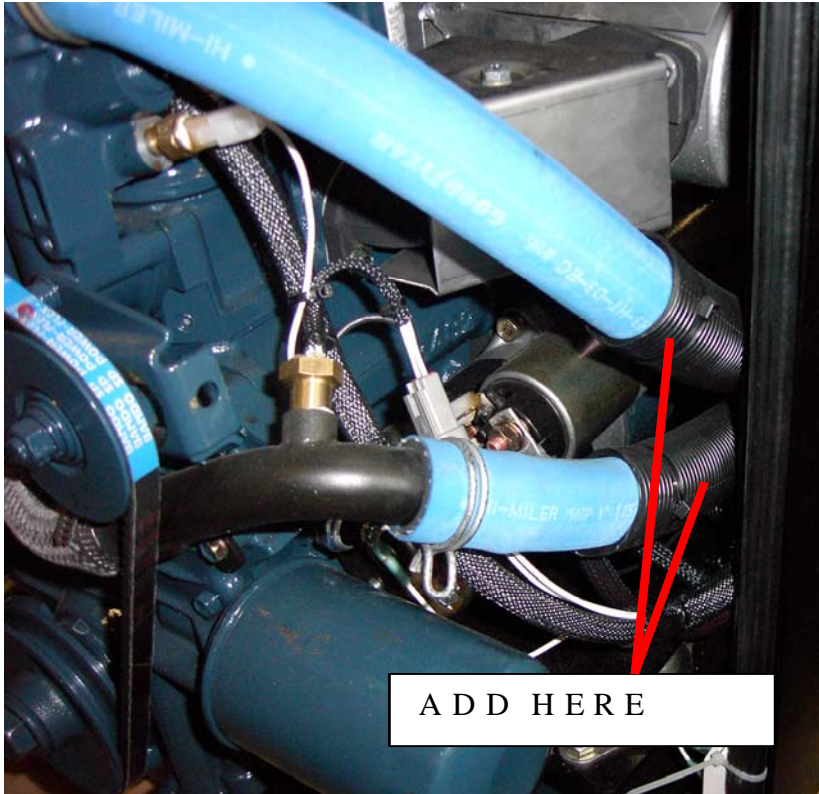
The APU coolant hoses may rub on the APU chassis. It is recommended that all serial numbers listed above be repaired.

- Wearing of coolant hoses.
- APU has a possibility of coolant leak.

1. Install Split loom over coolant hoses.
2. Use tie's to secure in place.
