LIGHTNING

SERVICE BULLETIN No.005

PRODUCT MODEL	: CCS Lightning
BULLETIN TYPE	: Product Correction
MANUAL / SECTION	: N/A
PARTS LIST REVISION	: 1064871-A
EFFECTIVE DATE	: April 5, 2006
SUBJECT	: Sticking Throttle Return Spring
UNITS AFFECTED	: Any unit with spring installed / No modifications
PARTS AFFECTED	: 1061352 Spring, Return
TERMS & CONDITIONS	:

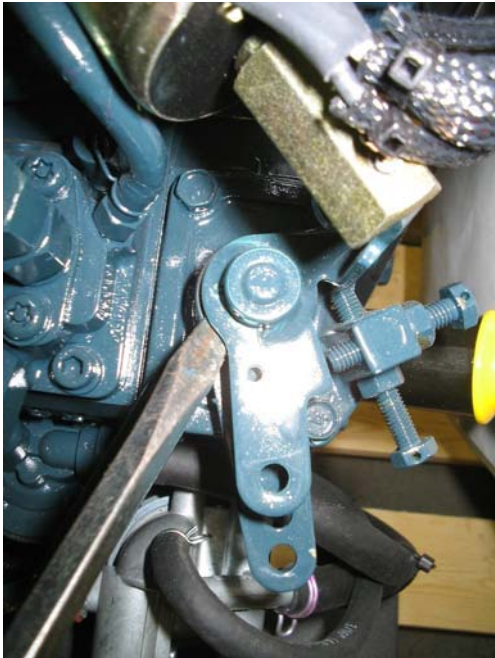
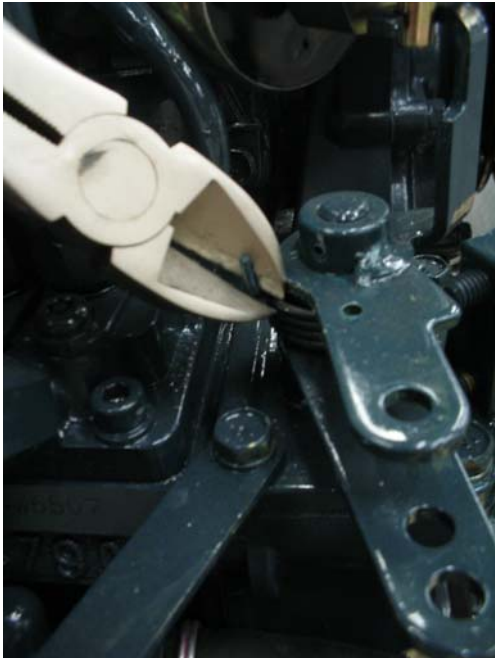
The APU Throttle Return Spring may cause the APU Throttle to stick open. It is recommended that all APUs be repaired during regular service or if the APU fails to shut down.

- APU will not shut down.

1. Remove 1061352 Spring, Return from 1061349 Lever, Engine Stop using a flat head screw driver.
2. Cut 1061352 Spring, Return using a pair of side cutter's or "dikes".
