LIGHTNING

SERVICE BULLETIN No.007

PRODUCT MODEL	: CCS Lightning
BULLETIN TYPE	: Manufacturing Correction
MANUAL / SECTION	: Workshop Manual – Section 7
PARTS LIST REVISION	: N/A
EFFECTIVE DATE	: July 12, 2006
SUBJECT	: Generator Alignment
UNITS AFFECTED	: Any units purchased prior to July 1, 2006.
PARTS AFFECTED	: 1058994 – Generator bearing housing
TERMS & CONDITIONS	: N/A

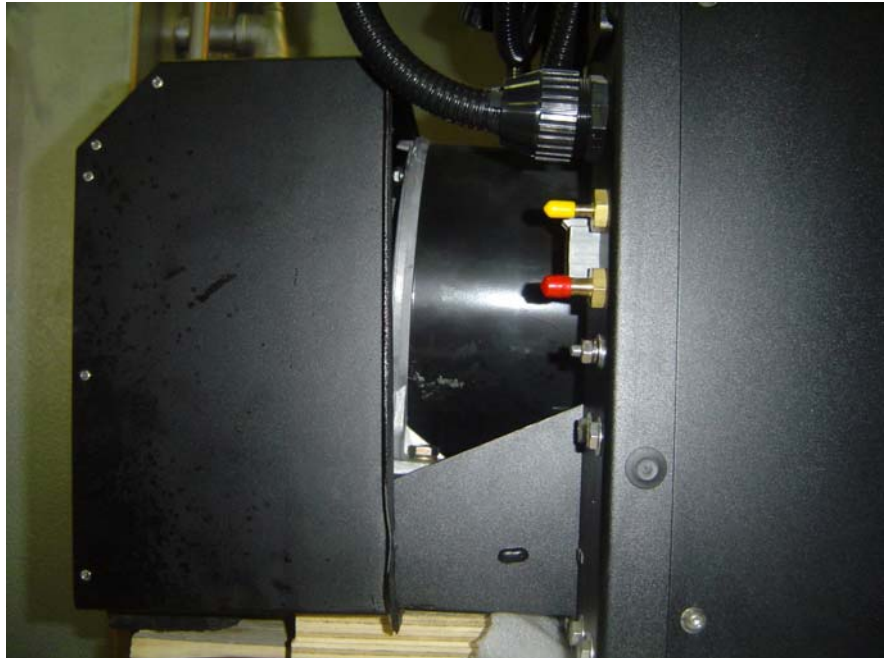
1. Remove 1069103 alternator cover assembly:

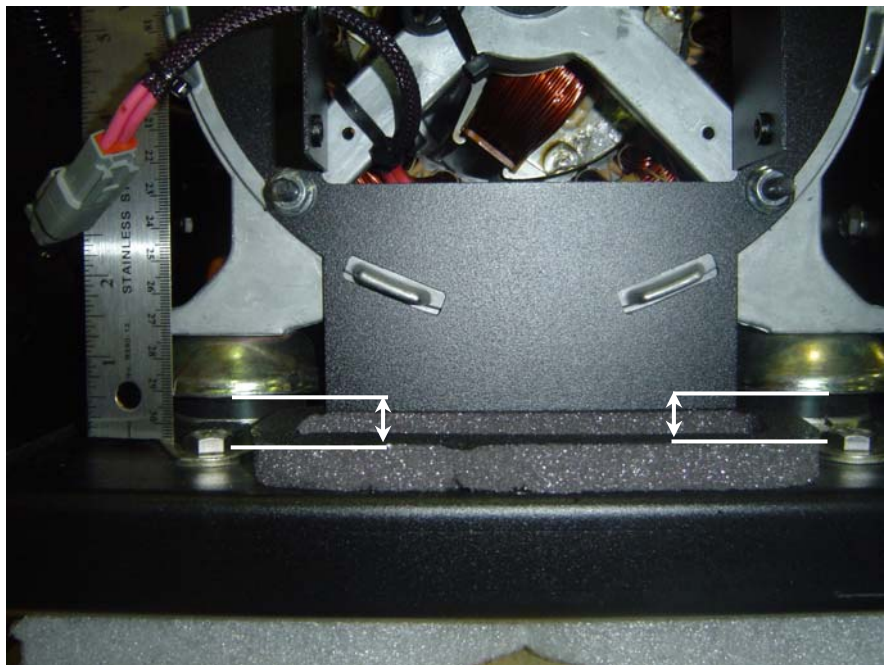
2. Measure and compare the isolator height by using a ruler to measure the distance from the bottom of the isolator cup to the base of the isolator (as shown). Compare the measurement between left isolator and right isolator.

If measurement differs by more than 1/16", proceed to 3. If not, install cover (no fault).

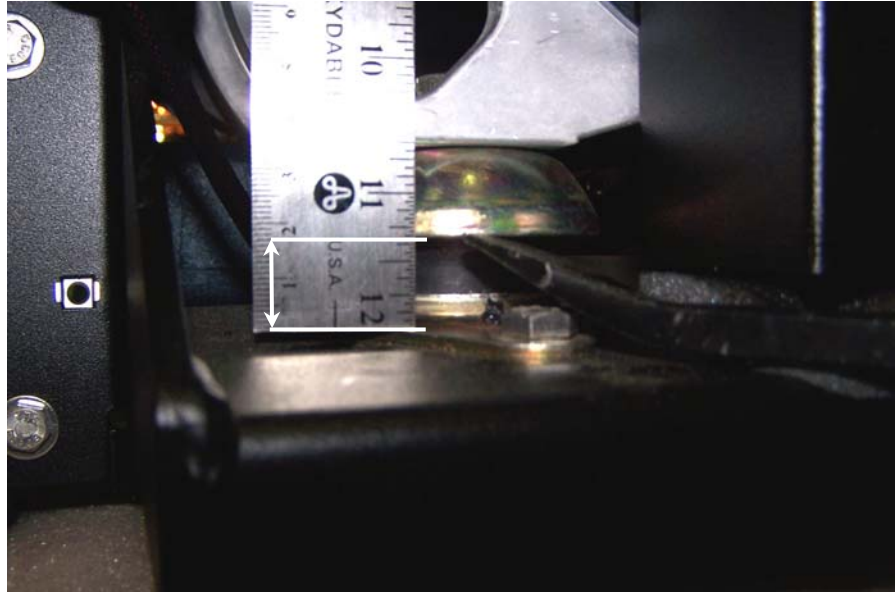
3. Verify the condition of the vibration isolator by using a pry bar. Pry up on the metal cup of the isolator. You should not be able to increase the height of the cup more than $11/16$ " (measured from the base of the isolator):

If prying on the cup increases the measurement by more than $11/16$ ", the isolator is defective and must be replaced.

Note: *The rubber is not bonded to the cup so the separation is normal.*
