SERVICE BULLETIN No.004

PRODUCT MODEL	: CCS Lightning
BULLETIN TYPE	: Product Correction
MANUAL / SECTION	: N/A
PARTS LIST REVISION	:
EFFECTIVE DATE	: December 6, 2005
SUBJECT	CABLE ROUTING CHANGE: BATTERY POSITIVE TO FUSE BLOCK ADDITION OF POSITIVE ISOLATOR BOOT ***MANDATORY FIX ON ALL UNITS AFFECTED****
UNITS AFFECTED	: 20060 TO 20119, 20747
PARTS AFFECTED	: 1059098 Harness, positive to fuse block.
TERMS & CONDITIONS	:

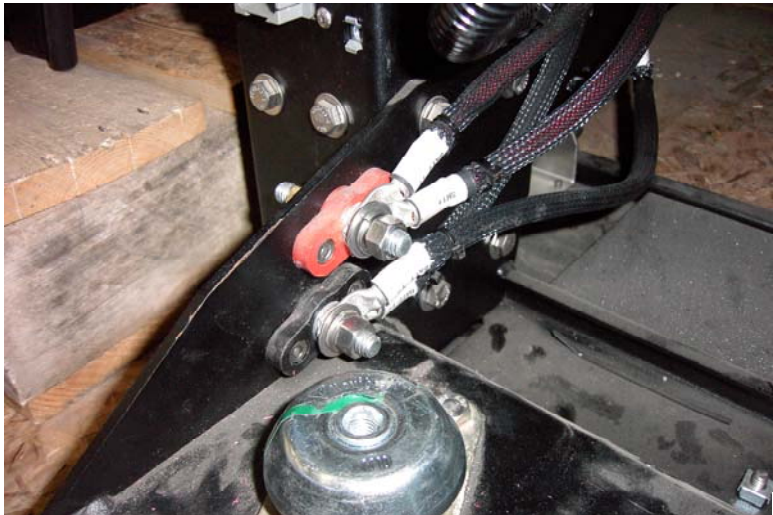
1. Remove APU's main 150 Amp fuse at the truck battery's.
2. Remove rear alternator cover on back of APU.
3. Inspect all mounting hardware for studs. Remove screws to mount studs one by one, add loctite and tighten.
4. Identify positive to fuse block cable on interior stud. Alternator removed for clarity.
